## Navigation for the Derbyshire Phase2 Survey

Technical Report

**WHOI-99-11**

**May 1999**

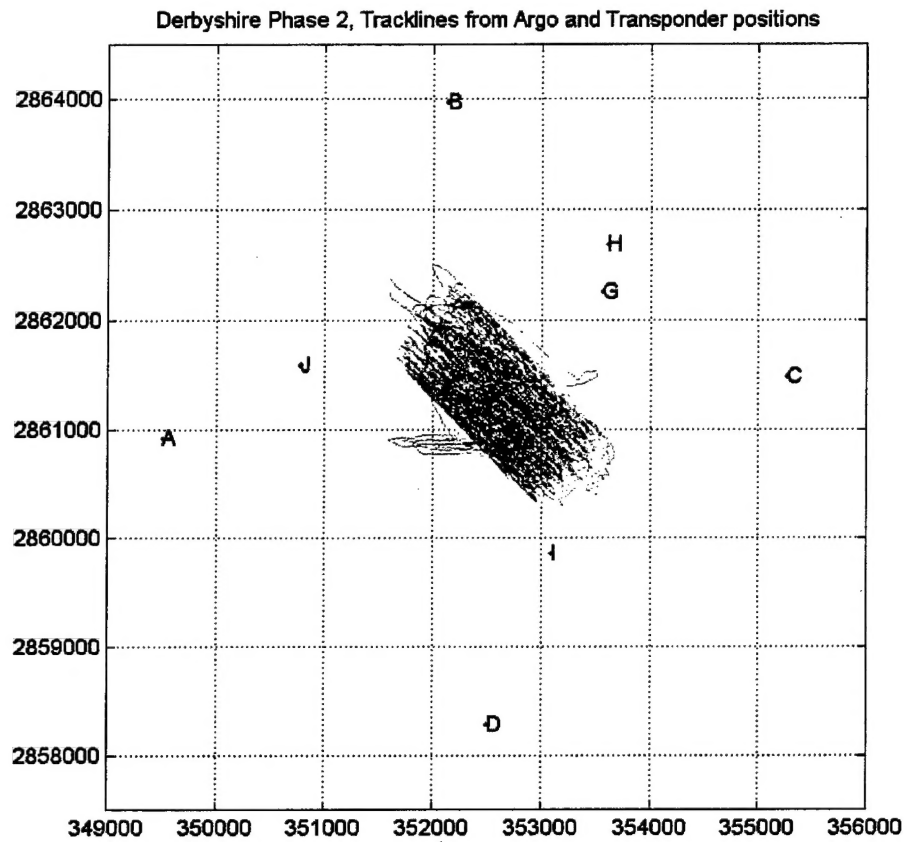
Figure 1: This plot shows the transponder positions and the complete set of Argo tracklines.

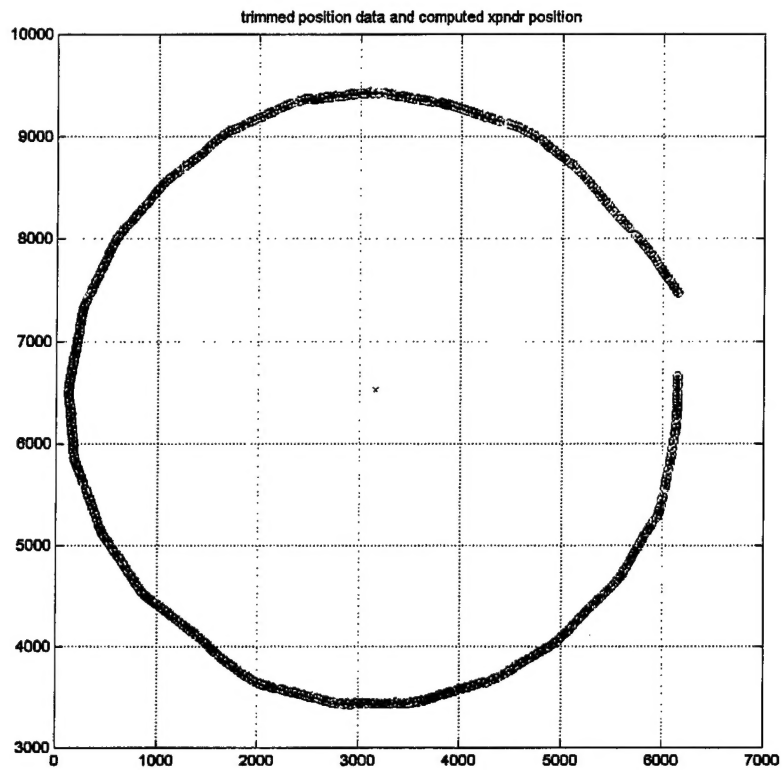
Figure 2. This plot shows the vessel track during a typical transponder survey. The apriori estimate of the transponder position (based on the launch position) is at the center of the circle. By using a circular survey pattern, we reduce the effect of many errors on the surveyed position.

Figure 2 shows a typical survey track. The pattern was driven at a speed of about 4 knots using manual or "hand steering" by the ship's bridge watch (DP is not used for the survey). A circle plotted on the ship's navigational display was provided to help in controlling the vessel. Each survey track required about 2 hours from completion. Results of the completed survey for all transponders are contained in Appendix A.

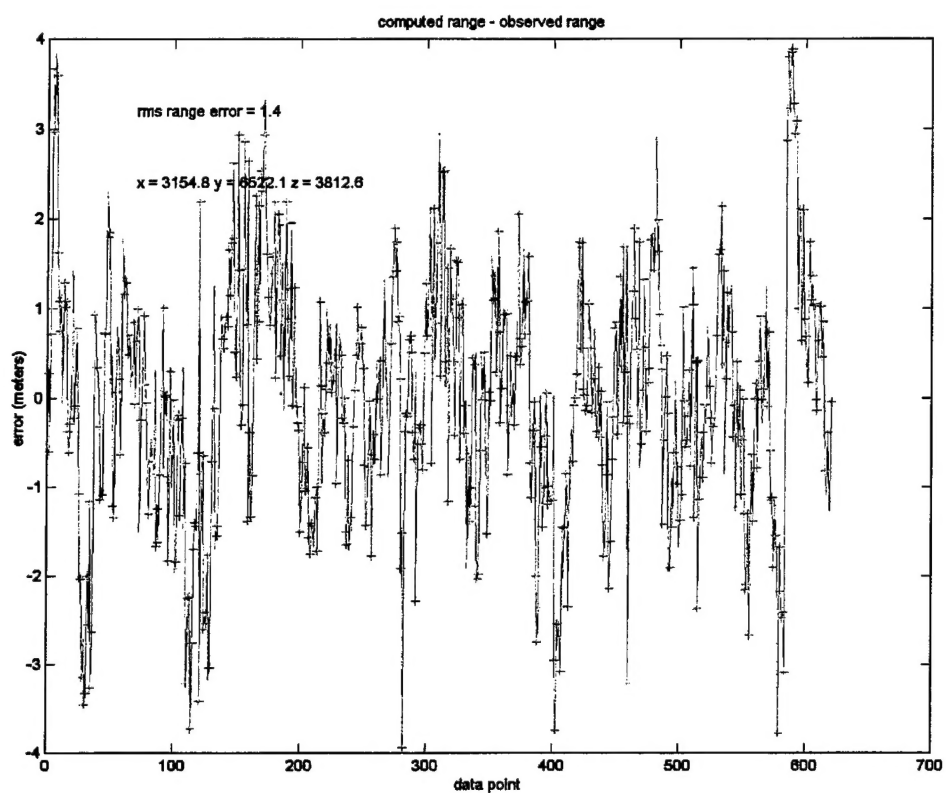
Figure 3. This plot shows the difference between the range computed from the vessel fixes and the surveyed position and the directly measured range.

Figure 3 shows the difference between the measured range (from the acoustic travel time) and the estimated range (from the vessel GPS fix and the estimated transponder position). The difference is low (1.4 meters rms) and any systematic errors are on the order of a meter. Figure 4 shows a histogram of the error distribution, which indicates an approximately gaussian error distribution.

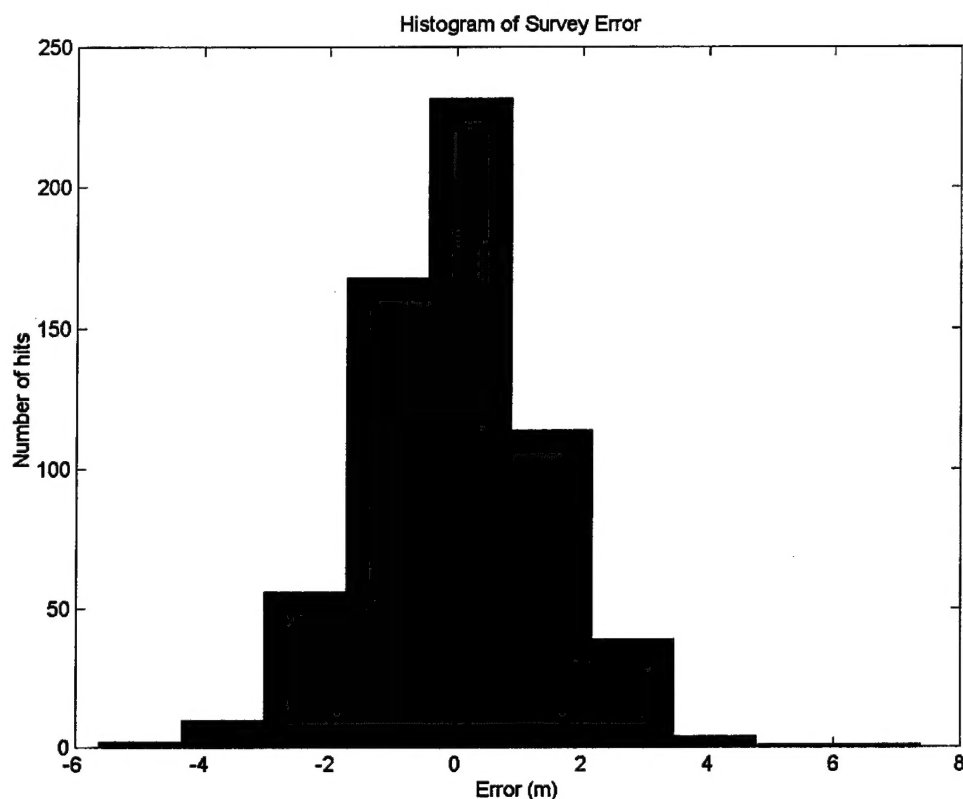
Figure 4. This plot shows the histogram of the range errors. While figure 3 shows some systematic errors, the final error distribution is fairly gaussian.

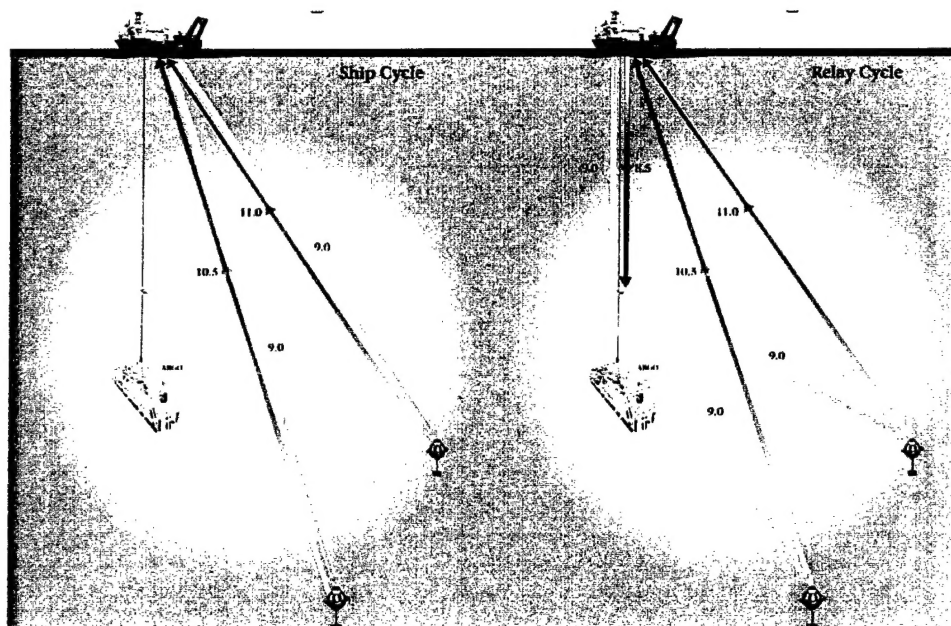
Figure 5: For both Argo and the DSL-120, we employed Relay Mode navigation. To obtain a solution, two cycles are executed. The first cycle determines the travel times between the ship and the transponders, and the second cycle interrogates the transponders through a relay transponder positioned on the tow cable approximately 100 meters above the vehicle.

For both DSL-120 side scan sonar and the Argo towed, we employed "Relay Mode" navigation. In relay mode, an acoustic cycle is executed for the ship, then another acoustic cycle is executed through the relay transponder on the tow wire above the vehicle. The reception of travel times at the vessel from the relay transponder and the transponders permits a 3D navigation solution to be computed. Conceptually, the solution can be compared to a 3 transponder, 3D solution, where the vessel plays the role of one of the transponders. While we usually have more than two transponders in our net (typically we had 5 or 6 during the Derbyshire survey), the navigator selects only two to use at any given time. With the ship effectively acting as a third transponder, we obtain a deterministic, three-dimensional fix with no intrinsic error measure. This cycle is summarized in figure 5.

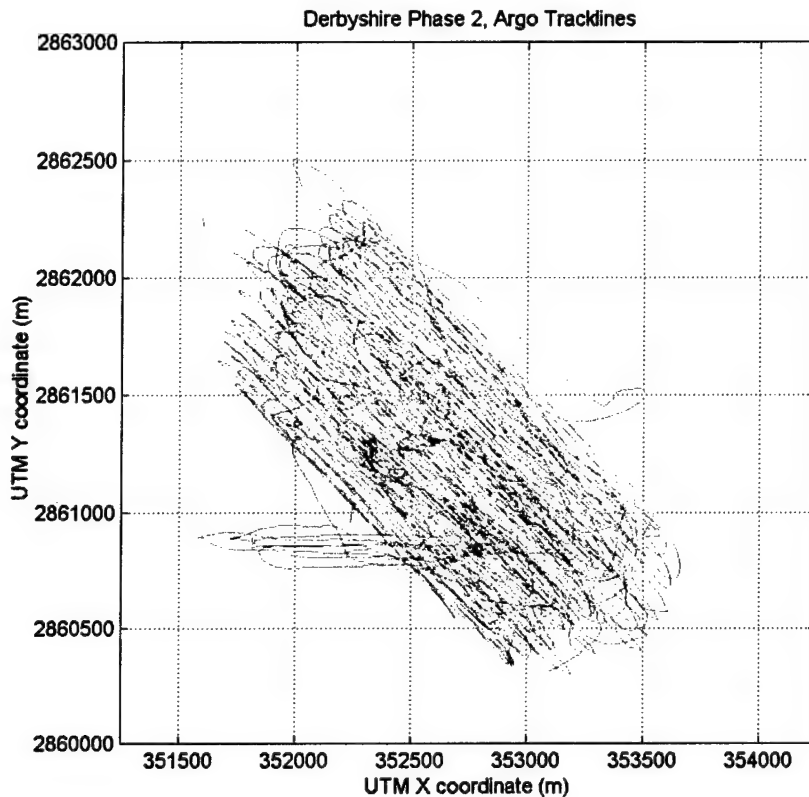
Figure 6: Complete set of Argo tracklines

Our goal was to obtain complete photographic coverage of the entire wreck site. As we control Argo primarily by maneuvering the vessel, this represented a challenge in over 4000 meters of water. In particular, the sluggish response of the vehicle to vessel movements makes the task difficult. Figure 6 shows the complete set of Argo tracklines.

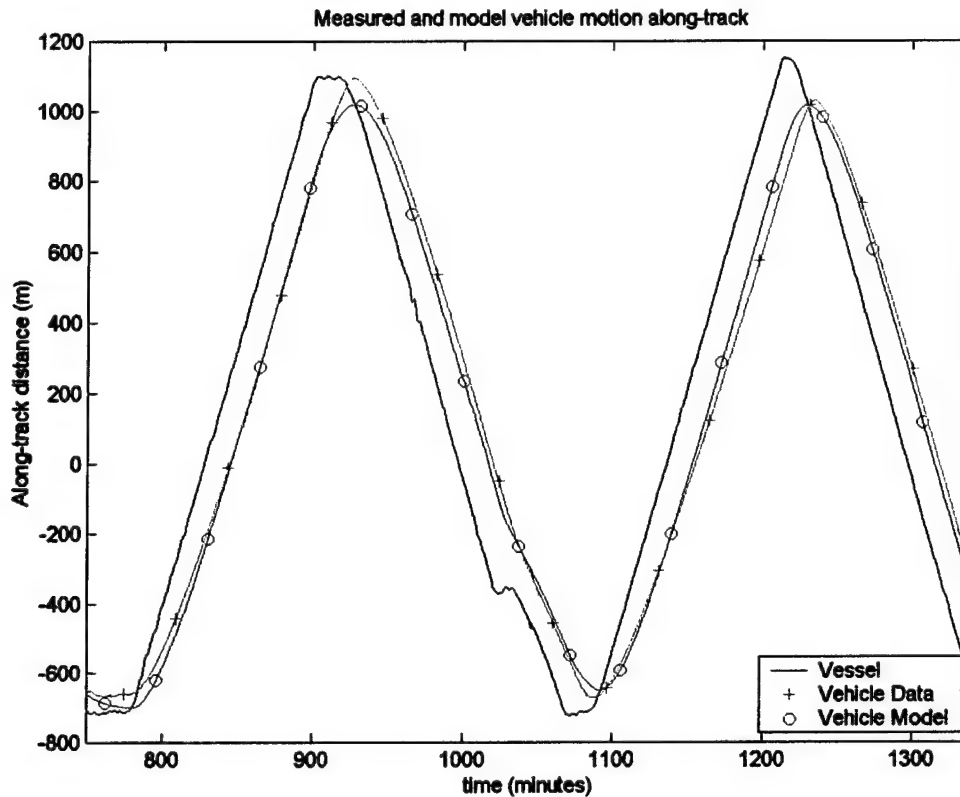
Figure 7 Modelled versus measured vehicle response along track. This plot shows distance traveled by the ship, vehicle, and a model. The model is a simple first-order system with a time constant of 18 minutes.

Figure 7 shows the dynamic response of the vehicle to vessel motion along with the response of a simple first-order model. Both vessel and vehicle movements have been transformed into a plane oriented along the nominal trackline direction. While the model is naïve in several ways (it ignores currents, depth changes, hydrodynamic nonlinearities, and out-of-plane motion), it clearly captures much of the relevant dynamics. It performs worst in turns, where the vessel motion is most extreme, velocity changes and out-of-plane motion are the large.

By fitting the model to the vehicle response, we can determine the time constant of the primary vehicle dynamic response to one-dimensional vessel motion. In the model shown in figure 7, the time constant was set to 18 minutes.

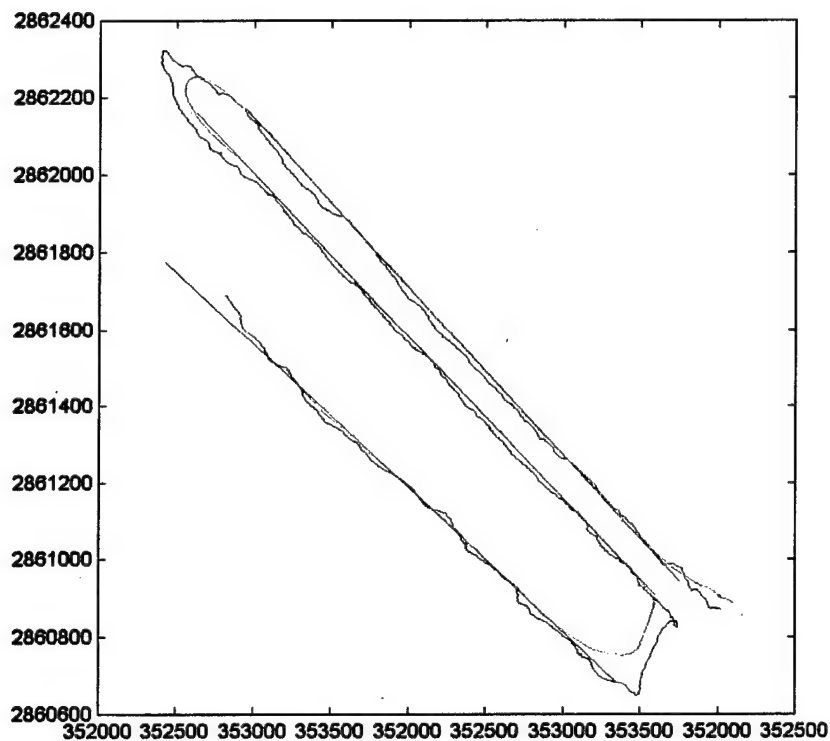
Figure 8: Typical track following performance. The red tracks shows the vessel trajectory, the magenta lines show the desired tracks, and the green trace shows the vehicle track.

Figure 8 shows typical trackline performance. The vessel movements, shown in red, were chosen to induce the vehicle to move along the trackline. Cross-track adjustments were entered at frequent intervals to keep the vehicle on the track. Due to the highly damped and sluggish nature of the vehicle response, these motions had to be exaggerated versions of the desired vehicle motion.

The corners in figure 8 show two different strategies. In the turn at the upper left corner, the navigator drove the vessel continuously. In the turn in the lower right corner, the navigator stopped the ship and commanded a rectangular turn with the vessel. The rectangular turn took more time than the continuous turn, but the vehicle converged on the new trackline sooner with the rectangular turn.

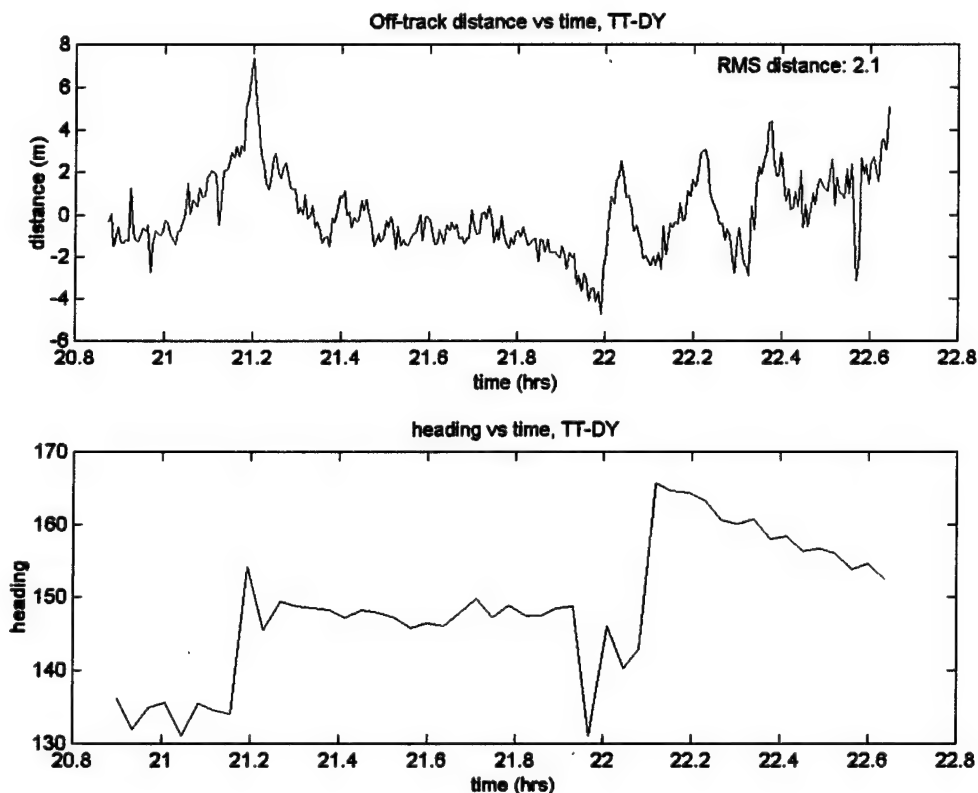
Figure 9. This plot shows trackline error and vehicle heading. As the track error grows just prior to 22 hours, a heading change is applied.

Figure 9 shows vehicle off-track error versus time along with the vehicle heading. The errors are quite low,  $\text{rms} = 2.1$  meters. Just before 22 hours, the vehicle trackline error starts to grow, and a heading was commanded to change in order to counter the error. This heading change (probably along with side thrust),

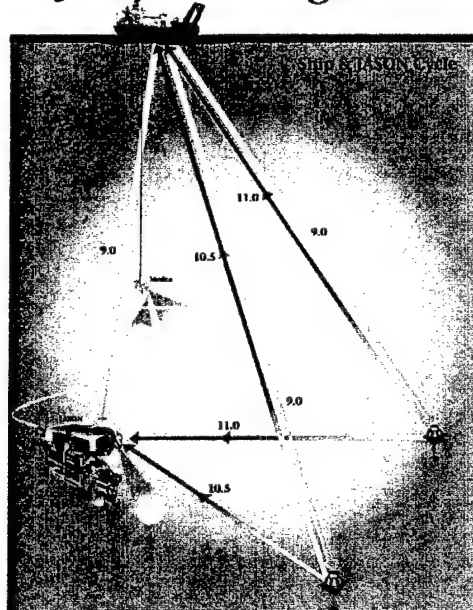
Figure 9. Jason uses a cycle where returns are received at the vehicle and the ship. In each cycle, we obtain a position fix for the vessel and either Jason or Medea.

Jason uses a different acoustic cycle than Argo, which allows the position of the ROV and its clump weight (Medea) to be positioned in alternate cycles. Figure 9 shows an ROV navigation cycle. The ship "pings" at 9.0 khz, which excites the transponders. The transponder replies are heard at the ship and the vehicle, which also hears the 9.0 pulse from the ship. This technique allows Jason's position to be determined in 3D in one cycle. Equivalent cycles for Medea were alternated.

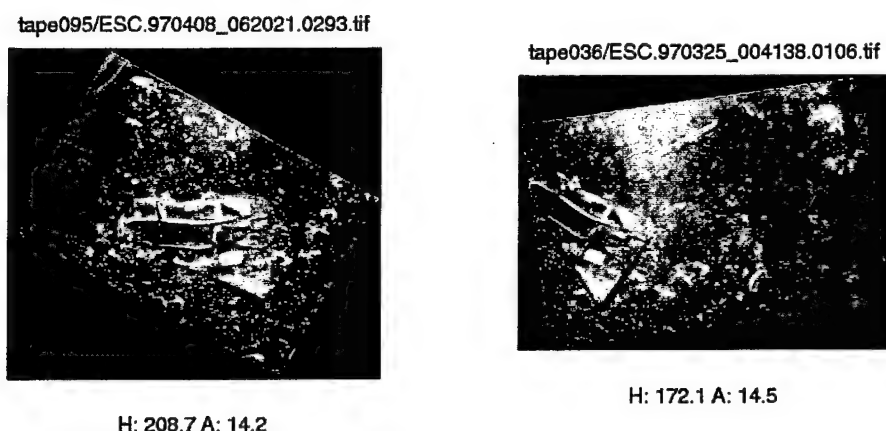
Figure 11: These two images show the same objects in different passes at different headings and altitudes. From tie points manually selected on each image, we can compute the offset between images for comparison to the offset derived from the navigation.

A typical image pair is shown in figure 11. These images have both been rotated using the compass so that each image has north approximately pointing up (compass errors can be clearly

seen). Features that appeared clearly in both images were chosen manually, then the offsets were computed taking into account the differences in height off bottom (from the altimeter measurement).

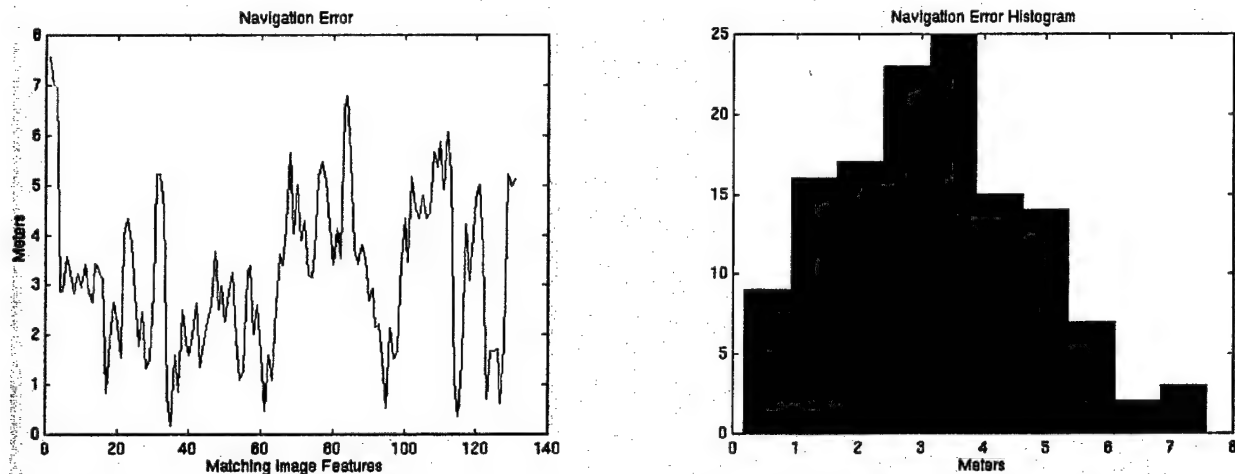
Figure 12. These plots summarize the discrepancies between the navigation and the images for the tie line. The average error is 3.1 meters. A total of 123 image pairs were analyzed.

Results were obtained for 123 corresponding images/navigation crossings along the tie line. The average error was 3.1 meters. For a more scattered sampling of 18 points over a wider area, the average position error was 1.9 meters. Both these results are well within our expected error magnitude of 5 meters. A collection of representative image pairs are shown in Appendix C.
